Oxidizer Decontamination of Building Materials Contaminated with Methamphetamine

John W. Martyny, Ph.D., CIH
Associate Professor
National Jewish Medical and Research Center
Division of Environmental and Occupational Health Sciences

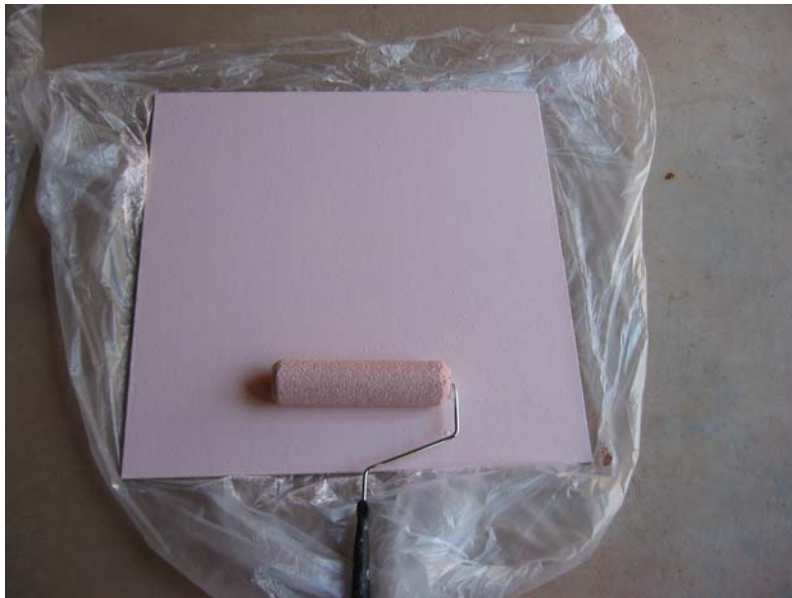
Figure 1. Painting drywall with a base paint prior to contaminating the board in the chamber.

This study was conducted to determine the impact of washing painted drywall surfaces with a cleaner containing an oxidizing compound. The drywall utilized in this project was 3/8th inch gypsum board that was cut into 24" x 24" squares. The drywall was painted with a latex enamel paint by painting the surface with two coats of paint, letting the paint dry and then painting it again with the same latex paint. Good coverage was provided and a gallon of paint was found to cover a total of 16 panels. After the painting, the paint was allowed to dry for a period of at least 2 days prior to contaminating the panels with methamphetamine.

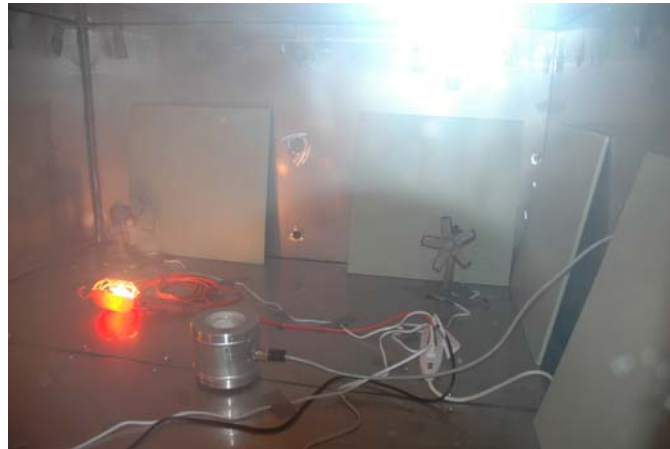
Figure 2. Painted drywall material being contaminated within the chamber.

After painting, the drywall panels were put into the chamber for contamination. A total of 9 drywall panels were contaminated on September 21, 2008 using 206 mg of methamphetamine. The methamphetamine was aerosolized starting at 12:40 pm and the

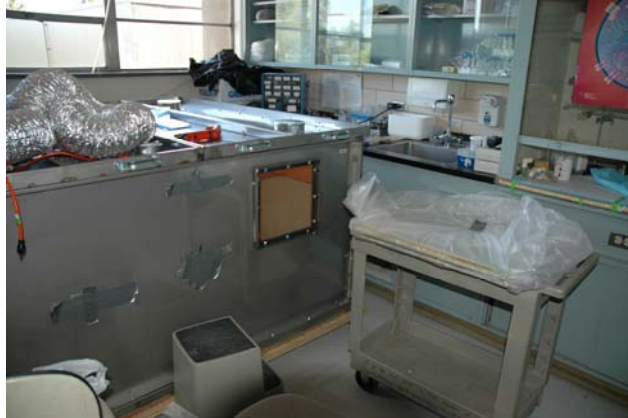
Figure 3. Drywall being removed for transportation to an area to be sampled and treated.

After the material was removed from the chamber, it was placed in a plastic bag and transported to an area to be pre-sampled, washed, and post sampled.

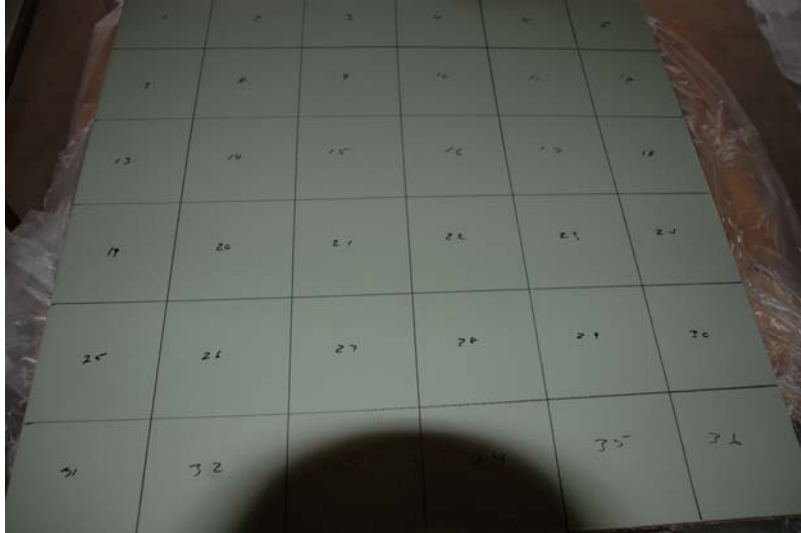
Figure 4. Panel prepared for initial pre-sampling after contamination.

For each panel, there were a total of 36 potential 100 cm² samples available. The squares sampled were determined using random number generator for each panel using numbers from 1 – 36. The two groups of 5 samples were generated with no replicates and the position of the samples were located on the panel using the following template:

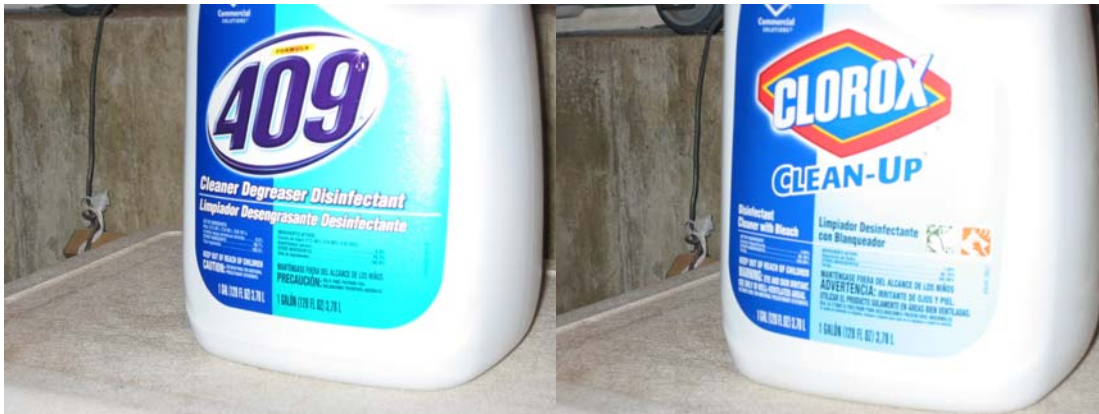
Figure 5. Pictures of the oxidizer cleaners utilized during this experiment.

The 409 cleaner contained 0.3% of alkyl dimethyl benzyl ammonium chloride and the Clorox Clean-Up contained 1.84% of sodium hypochlorite. Both products are manufactured by Clorox Corporation and are sold in retail outlets. The Material Safety Data Sheets for these products are attached to this report.

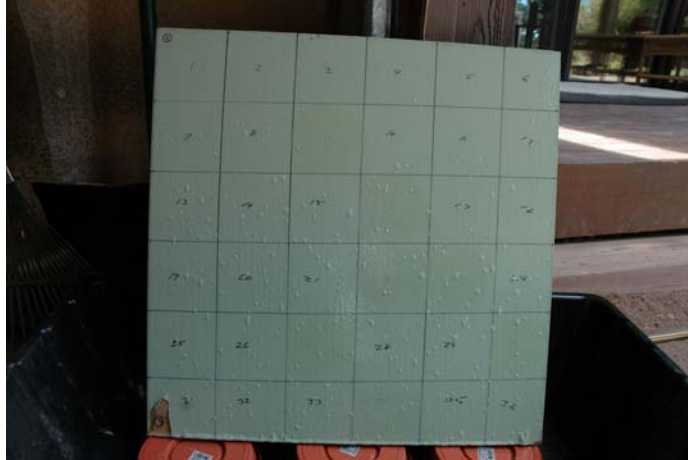
Figure 5. Washing the panel with the oxidizer solutions.

After the collection of the pre-samples, the panels were then washed for the prescribed number of treatments using the appropriate cleaner. The cleaner was used according to label directions for a maximum degreasing. The cleaner was applied full-strength from a spray bottle onto the surface of the panel. The cleaner was allowed to sit on the panel for approximately 1.5 minutes and then it was washed off using clean water and a cloth. The surface was not scrubbed hard and no abrasive materials were utilized. After cleaning, the panels were allowed to dry completely before subsequent cleanings or prior to post sampling.

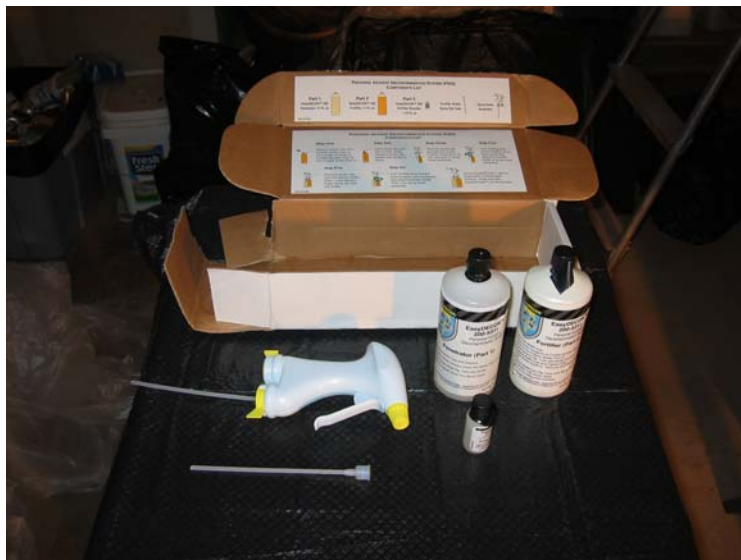
Figure 6. The EasyDECON kit containing the three-part decontamination material prior to assembly.

On January 19, 2009 the third experiment was conducted to determine if an oxidizing agent supplied by EFT Holdings Inc. and developed by Sandia National Laboratories would also be effective in reducing methamphetamine levels on painted drywall. This compound is labeled as EasyDECON and is supplied in three parts by the manufacturer. The three parts include a Penetrator that is a quaternary ammonium product, a Fortifier that is a liquid hydrogen peroxide, and a Booster that is labeled as a diacetin in the MSDS. The three parts are added together immediately prior to spraying them onto the surface. The manufacturer also does not require that the compounds be removed from the surface but does require a 30 minute contact time in which the surface must be wet. The product is a foamy material when applied to the surface.

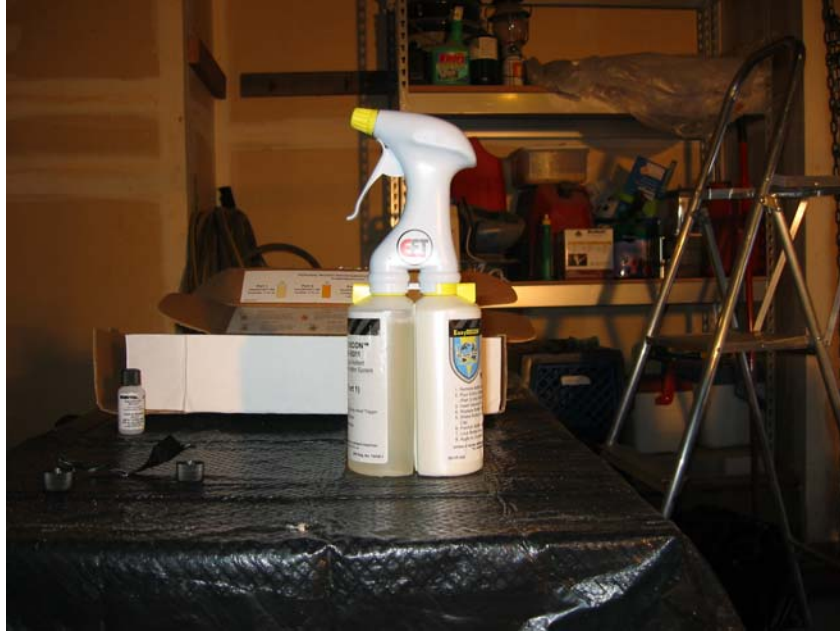
Figure 7. The EasyDECON solution application unit after assembly and prior to surface treatment.

This portion of the experiment was conducted in the same manner as the above two oxidizers except that the product was applied with the spray bottle that was provided and then let sit for a period of at least 30 minutes in a wet state. The product was then allowed to dry and the samples were collected in the same manner as in the previous samples. Samples were only taken from the painted drywall material. Seven samples were collected prior to treatment and after treatment, resulting in a total of 14 samples being taken from each of the drywall panels. Each sample consisted of a 100 cm² area being sampled from the panel using a 3"x 3" cotton swab to which 3 ml of methanol were added. After sampling the wipe was then put into a plastic centrifuge tube and sent to the laboratory for analysis as in the previous testing.
